LIVENARCH VII

7th International Congress

September 28-30 2021 Trabzon TURKEY

RESIDENTIAL TYPOLOGY RESEARCH ON RURAL ARCHITECTURE HERITAGE: ÇAVUŞ VILLAGE (KONYA, BEYŞEHİR)

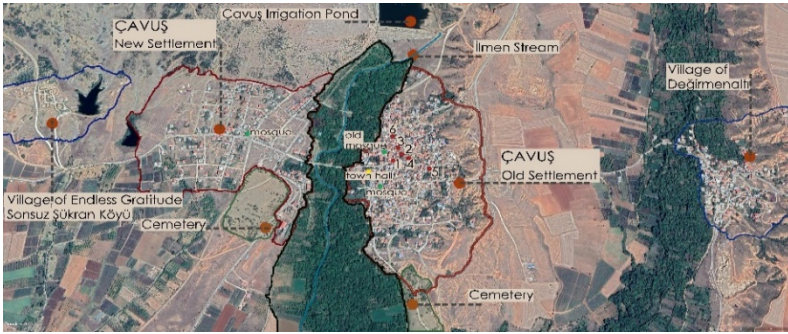
Figure 1. Layout Map of Çavuş Village

The village, which is 40 km from Beyşehir, is located at the foot of Sultan Mountain and is 8 km far from the lakeside. Although it is extremely close to the lake, there was a water problem in old times. The main water source of the village is Ilmen Stream passing through the village. The water requirement had been provided with dams, chanel, wells and fountains until the electricity came, and it played an active role in configuration of this settlement. As seen Figure 1., Çavuş Village, located on both sides of the valley formed by Ilmen Stream, differs in terms of its settlement plan. While the east of Ilmen stream is the first settlement area of the village, the settlement pattern has a dense and organic distribution. On this side of the village, there is a mosque-centered village square. There is also a coffee house overlooking the village square and two plane trees in this square. There is an old town hall at one's foot to square. While the new settlement area is in the west of the stream, the settlement plan is gridded and the

settlement texture is low dense. To the west of this residential area is Sonsuz Şükran Village. There are two cemeteries in the southwest and south of the village. Gardens/orchards are in the area between the two cemeteries and stretching along the stream. In the village, which has its own plateau and grove, there are Ottoman bridge and mosque, baths thought to be Roman artifacts, two pre-Islamic mounds and Roman ruins (Erdoğan, 2003).

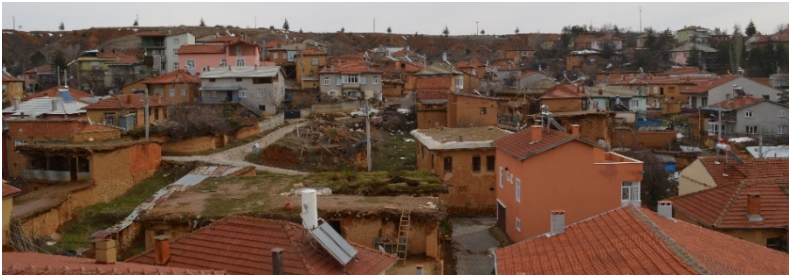
Figure 2. View of Çavuş Village

Besides the historical monumental buildings, the traditional residential texture as seen in Figure 2. also shows a diversity in this settlement area. One of the most significant features of this place is the special geographical location that creates a transition between the Mediterranean Region and Central Anatolia Region. Through its vernacular climate structure, natural water resources, vegetation, and soil structure, the Lakes Region has caused the settlements there to develop differently. In this region, there are stone, wooden, and mudbrick buildings in the settlements that can be considered as Rural Heritage. Some buildings can provide information about the region as adobe buildings.

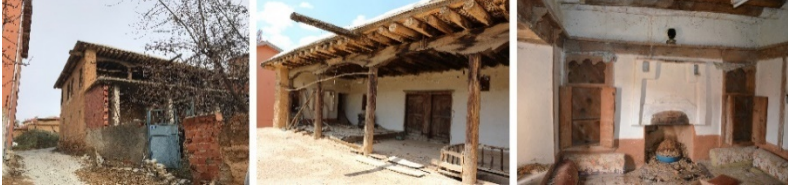
Figure 4. House no 2: Exterior View, Exterior Sofa (Çardak), Room

House no. 2, The Rifat Gültekin House; As seen Figure 4., It is one of the oldest buildings in the village and is said to be 200 years old by the local people. The year 1876 is written in the Arabic alphabet on the outer sofa. There is no direct entrance to the building from the road. The parcel, which has a road on three sides and an adjacent house on one side, is entered through the garden gate. The adobe garden walls, the barn units and the village room, which was said to have existed before, have not reached today. The building, which consists of a ground floor and an upper floor, has an outer sofa called “çardak” in local terminology. It is one of the original examples of the houses with outer sofas, built with mudbrick, found in the Beyşehir Region. The structure was partially intervened by laying bricks in place of the damaged mudbricks and adding a reinforced concrete terrace parallel to the outer hall. The three rooms, two of which are “izbe”, on the ground floor are entered from the front garden under the sofa. It is estimated that the room on the ground floor served as the kitchen and winter preparation space, due to the hearth, various pots, and jars inside. There are three rooms located parallel to the sofa in the building, which is accessed by a wooden staircase to the outer sofa. The building, which has the longest outer sofa in the village, has a hearth on both short sides of the sofa. In addition, the floor of the hearth, located to the west of the sofa, has windows on both sides, and the sitting area and circulation area are separated by making a bench in front of this wall. The room to the west of the sofa is defined as the main room of the house. The main room has the largest number of windows and walk-in closets in the residence, as well as elaborate and rich decorations. All rooms have a window opening to the outer sofa and a window facing the outside, on the other hand, there are two more windows next to the stove in the main room. The rooms reflect the original character of the traditional rooms in the region in terms of spatial organization, equipment, and decoration.

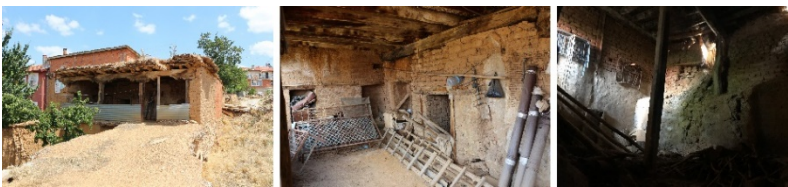
Figure 5. House no 3: Exterior View, Exterior Sofa (Çardak), Hayloft

House no. 3, The Mustafa Aydın House; As seen Figure 5., It is one of the rare and original examples of Çavuş Village houses in terms of parcel layout. The two-storey adobe building is directly accessed from the road, and right across from the entrance, the place called “hayat” is passed to the inner courtyard. The stables, and barn are accessed from the courtyard surrounded by walls and structures. Previously, it was reported by the owners of the house that a room was also located in this courtyard. In addition, the two-storey house, which is used today, has an inner sofa and oriel window, has undergone a serious repair and has lost its originality in planimetry and façade. In the original and also today, the roof of the barns is passed from the hall on the second floor of the house, and this earthen roof is used as a terrace by the house owners. From this terrace, one passes to the semi-open space, which is called “çardak”, which is similar to the outer sofa in front of the hayloft. The owner of the house said that his grandfather's loom was located here and that his grandfather did his weaving work in this place (Mustafa Aydın, 2021). There is a window facing the hayloft in the covered terrace, which faces the inner courtyard and is carried by wooden posts. The hayloft has a height of about two floors and has an entrance from the secluded place under the terrace in the inner courtyard. Moreover, there is an unused draw well in the hayloft. The level difference was used on the road front of the hayloft, and a separate window was opened to throw straw. Because the width and height of the hayloft exceeded four meters, another pillar was placed in the center. The originality of the non-residential functions is important in terms of the use of independent terrace from the interior and the feature of benefiting from the elevation in the settlement.

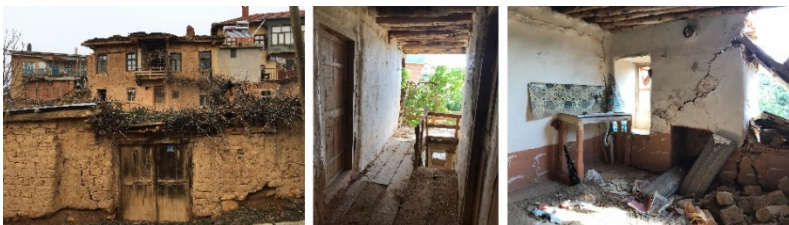
Figure 6. House no 4: Exterior View, Partially Open Inner Sofa (Sala), Room

House no. 4; As seen Figure 6., It is located on a sloping plot and its two opposite sides face the road. The building, which has three floors due to the slope, is one of the few examples in the region with more than two floors. There is a passing to the building via the garden on the lower level and the

road on the upper level. The sofa of the first floor of the building is opened to the road on the upper level, but its original use is not known because the damage is extreme in the building. The courtyard, surrounded by mudbrick walls, is accessed from the road on the lower level, as well as the basement and ground floor are reached from the courtyard. The wooden staircase to the ground floor from the outside has been demolished today. While some of the housing support units in the courtyard exist, some of them have been demolished. The basement floor could not be entered, and it is presumed that it was used as the barn and warehouse functions. There are rooms opening to the intermediate space on the ground and first floors where the residential unit is located. The fact that one side of the building is adjacent to the neighboring building and that a part of the ground floor is below the upper road level indicates that some of the rooms or spaces cannot receive light. Since the building was in danger of collapsing, only the top floor could be entered, and the places with collapsed walls on the lower floor could be photographed. There are three rooms on the upper floor. A part of the adjacent building enters the building, and the house has an L-shaped plan scheme. For this reason, there are two rooms on the left and one on the right of the stairs. The ground floor and the first floor are connected by a wooden staircase to the left of the entrance leading to the sofa. It is one of the last examples of the house with a partially open inner sofa, which is one of the original plan typologies of Çavuş houses. In this typology, the staircase connected to the sofa of the lower floor, which is entered from the courtyard, reaches the partially open sofa on the upper floor. The section behind the staircase extends to the open space that functions as a balcony over the entrance door. The partially open inner sofa space seen in the region is called the "sala" in local terminology. The three rooms opening to the sala represent the characteristic features of the region. In addition, the white patterns called "whitewashing" (aklama) or "speckle pressing" (benek basma) (Karakul, 2019) applied to the wall surface with different techniques and tools on the soil plaster application seen indoors and outdoors around Çavuş are also seen in rooms of the house.

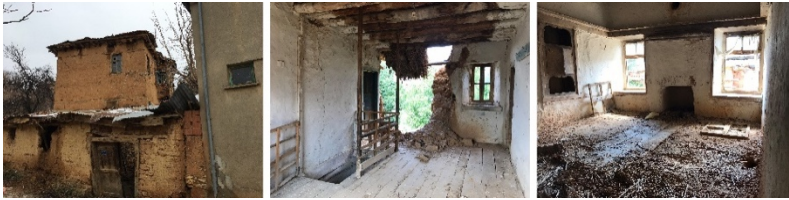
Figure 7. House no 5: Exterior View, Inner Sofa (Sala), Room

House No. 5; it represents another parcel settlement example in the region in terms of its features such as the short front of the house to the road, its side entrance relative to the road, and its perpendicular placement on the slope. The courtyard of the building, which is adjacent to the adjoining parcel on two sides, is surrounded by buildings and the courtyard wall is only on the front road. The courtyard is accessed through the double-winged door

opening to the road, and the residence and other units are accessed from the courtyard. While the elevation was used in the sloping courtyard, the barn, the hut, and the house at different levels are entered from the façade on the left of the entrance. On the façade opposite the entrance, a shed with a front porch is positioned. The seclusion, which has a separate entrance to the left of the house entrance, has a height of approximately 1.50 m. This independent space, which is obtained from the level difference due to the slope, is located under the house. The house has two floors and a mezzanine floor. This mezzanine floor, which is located on the lower floor, consists of a room. The room is entered from the landing of the stairs in the living room and the landing level is 90 cm higher than the entrance. From hayat one also enters a warehouse-pantry space. On the upper floor, there is a sala and two rooms. The rooms are entered from the area behind the wooden staircase leading to the sala. The sala that extends over the staircase has a cantilever. It is thought that the closed cantilever of the sala, which is common for most buildings in village, was enwalled later. In this cantilever, there is a door that leads to the earthen roof of the barn. The building has three rooms, one of which is on the mezzanine floor, and these rooms preserve their originality. The back wall of the building, which is not used today, was partially destroyed. As seen Figure 7., in terms of plot layout, mezzanine use, plan typology and room organization, it has the specific features of the local architecture.

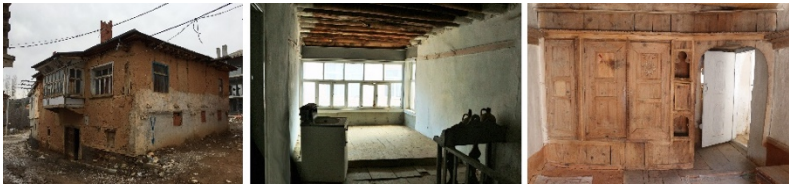
Figure 8. House no 6: Exterior View, Inner Sofa (Sala), Room

House number 6, Ali Sezgin House; As seen Figure 8., it is the only listed building in the village. According to the owner of the house (Sezgin, 2021) although the building is similar to house number 3 in terms of parcel layout, only the residential building part remains today. Partial collapses are observed on the facade walls of the house, which is not used today. The hayat of the two-storey house, which was originally entered from the road, leads to the courtyard at the back, and from the courtyard to a barn, a stable and hayloft. Two spaces used for storage on the ground floor are entered from the hayat. The application of local decoration technique, white pattern on the soil surface, can be seen in the hayat and these rooms. The wooden staircase to the left of the entrance door leads to the sala on the upper floor. A platform “seki” called in local terminology was built in sala behind the stair walking direction. This seki extends to the cantilever, approximately 1 m from the house façade. The closed cantilever, located just above the entrance door, was later enwalled according to the house owner. In its

original form, the house has a plan type with a partially open inner sofa. The other opening of the sofa opposite the cantilever was later closed as a bathroom and WC. According to the statement of the house owner, there was a staircase leading down to the courtyard from the opening here before it was closed. From the Sala, there are entrances to three rooms, one on the left of the stairs and the other two on the right. The room to the left of the staircase served as the main room of the residence. The head room, which has the most decoration and fine workmanship in the building, reflects the traditional room organization in the region. Inside the room, there is a ghusl and a cupboard, an arched passage between the entrance and the cupboard, a shelf that continues along the wall, two built-in wardrobes with craftsmanship, shelves and a mirror. While there was a hearth between the two windows in the room before, the hearth was removed by enlarging the window later. The same application can be seen in the other room on the front facade.
